CASE HISTORY

COMPLETE PLANT FOR THE PRODUCTION
OF THERMAL-BREAK PROFILE

TURN-KEY PROJECT FOR THE PRODUCTION OF THERMAL-BREAK PROFILES

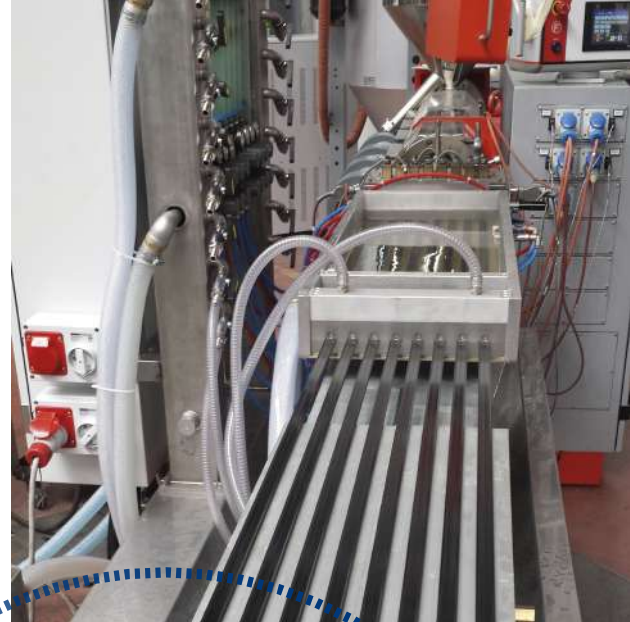
The plant is composed of a single-screw extruder **Omega 80** with PLC, in which the raw material arrives already dried, and **classical downstream** with insertion of auxiliary machines.

The control of the 8 strands is assured by a **dedicated calibrating system** with die-calibrator centring which allows a perfect alignment and facilitates the positioning of the profiles.

The flexibility of the extrusion plant has allowed the insertion in line of a sandblasting unit and a glue insertion system.
